Site Visit Report	Project: Aqcha Citizen Service Center
Location: Jawozjan Province	Coordinates: Latitude: 36°54'5.69"N Longitude: 66°11'1.81"E *Coordinates are estimated
Inspection Date: November 6, 2013	Weather: Partly Cloudy, Temp @ 18°C, No Precipitation
Inspectors:

Status: Incomplete

United States Agency for International Development (USAID)
Office of Economic Growth and Infrastructure (OEGI)

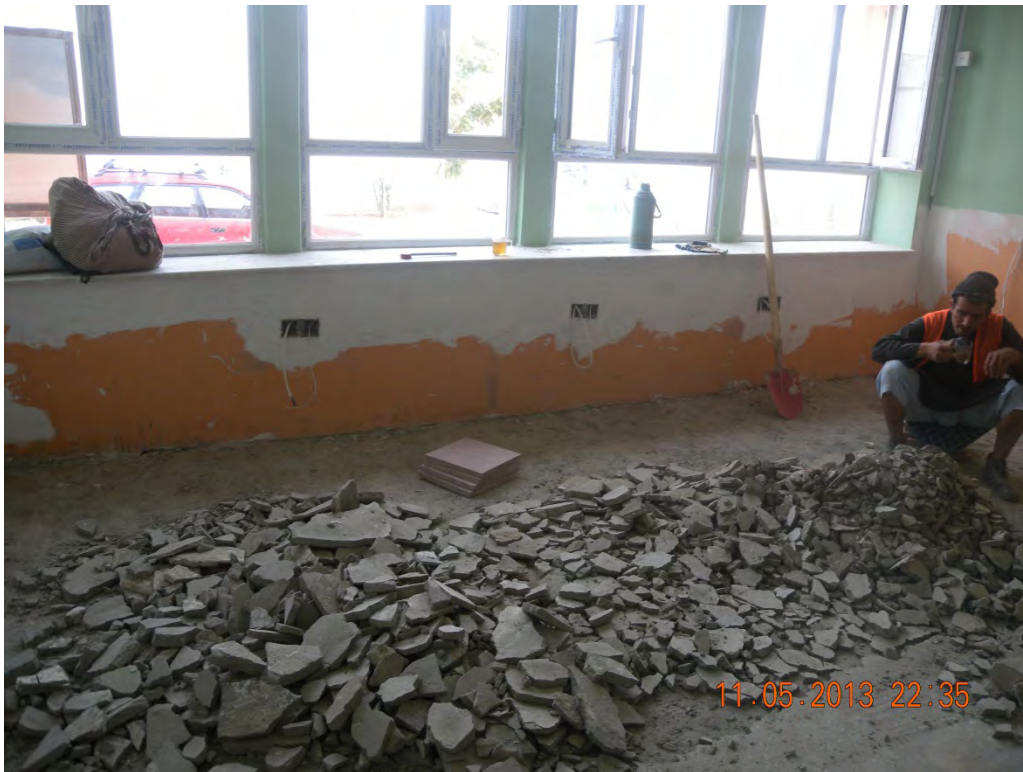
Figure 1. Removal and Demolition of Existing CSC Building Floor

1. Replacement of the CSC floor is incomplete. (See Figures 1 and 2) The old floor of the CSC building has been demolished and marble tiles for the replacement had been stockpiled.

- a. **Remaining work:** The contractor is required to install and furnish the marble tiles for the floor of the CSC building.
2. Construction of the septic tank is incomplete. (See Figures 14, 15 and 16) Septic tank's side walls and bottom slab with all plastering works are completed per drawings, however, the plastering of the septic tank and construction of the top slab remains.

1. Plastering of interior and exterior walls of the CSC building is complete.
2. Installation of fans, light fixtures, switches and fuse boxes in CSC building are complete. (See Figures 5, 7 and 8)
 - a. **Remaining work:** The contractor is required to install receptacle outlets in CSC building. (See Figure 1)

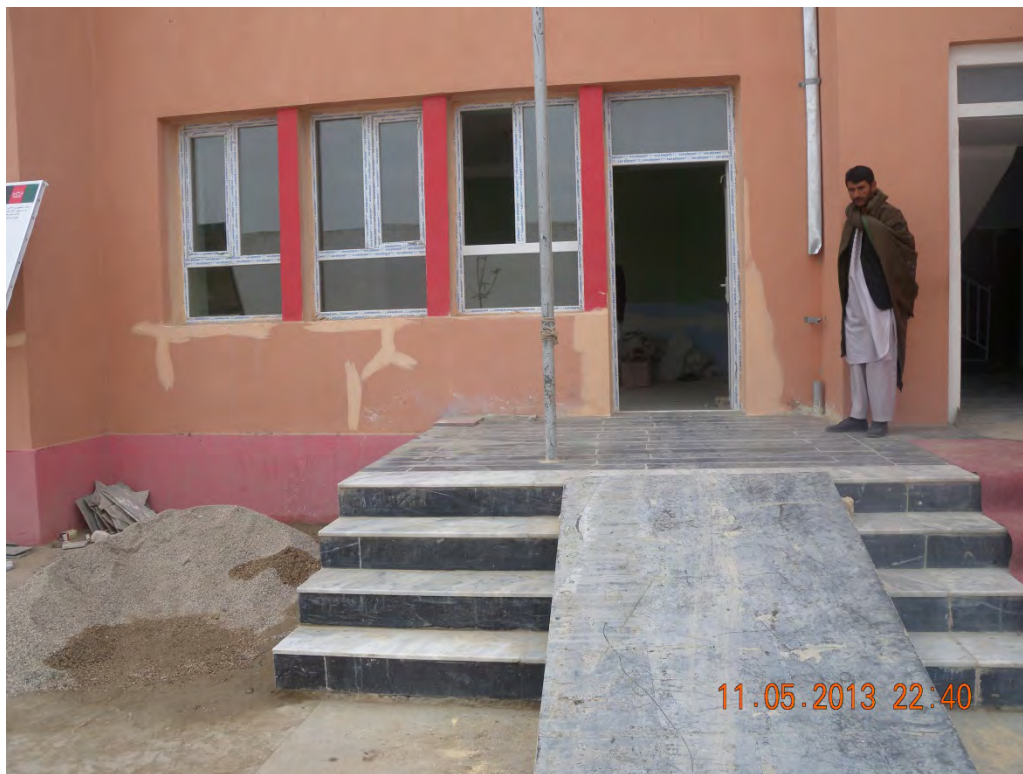
Figure 3. New Entrance Platform with Stairs

3. Construction of platform for toilet and main entrance of CSC building is complete. (See Figures 3 and 9) They appear to be constructed in compliance with the drawings.

4. Installation of PVC doors and windows for toilet and CSC building is complete. (See Figures 3, 4, 6, 9 and 13) This appears to comply with the drawings.

3. All renovation works related to latrine is complete. This includes installation of boiler, shower, light fixtures, receptacle outlets, exhaust fan, switches, junction boxes and sinks. (See Figures 10, 11 and 12.)
4. 3-coat painting of CSC building is incomplete. (See Figures 3 and 4)
 - a. **Remaining work:** The contractor is to complete the painting of the CSC building.
5. Interior wooden wainscoting is incomplete. It is to be 120 centimeters in height and cover the lower part of the interior walls. Construction is yet to be started.
 - a. **Remaining Work:** The contractor is to install interior wooden wainscoting.

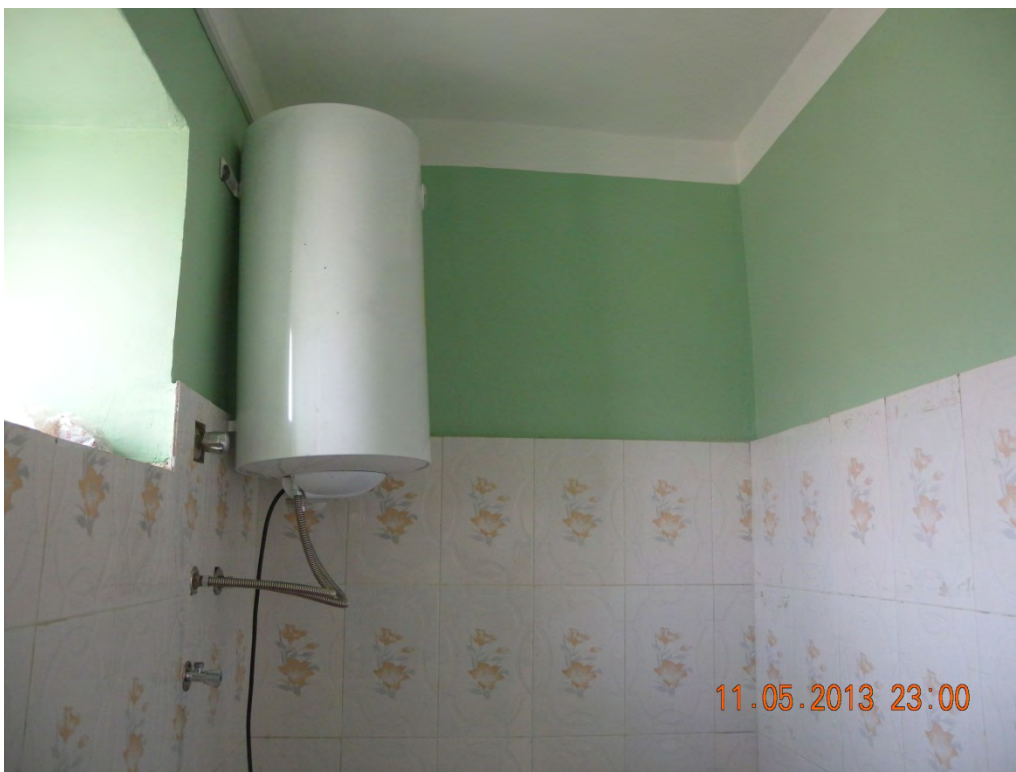
Figure 10. Boiler in the Bathroom (100 liters)

5. Construction of a partition wall in toilet is complete. This appears to comply with the drawings.
6. Installation of ceramic tiles inside the latrine is complete. (See Figures 10 and 11)
